REPAIRING ALUMINUM WIRING

U.S. Consumer Product Safety Commission
Bethesda, MD
www.cpsc.gov
www.SaferProducts.gov

Publication 516

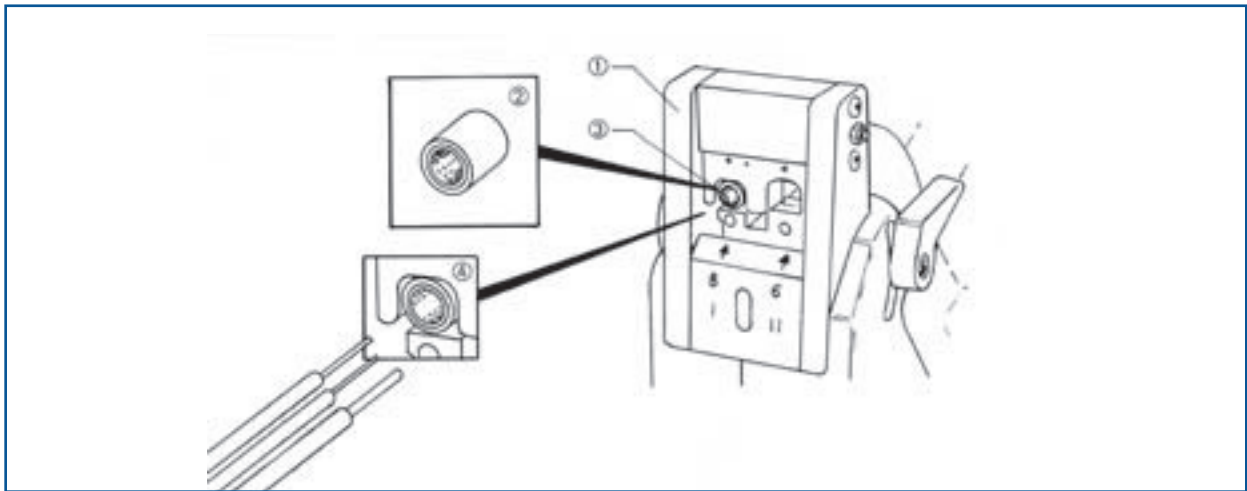
The COPALUM connector is a specially designed system that includes a metal sleeve intended to be installed only with a dedicated power tool and crimping die to make a permanent connection, that is, in effect, a cold weld (the precision dies in the COPALUM tool compress the connector and wires using upwards of 10,000 pounds of force, as required to make the permanent aluminum wire connection).

COPALUM Crimp Connector and its Specialized Installation Tooling

The tool is shown in the illustration below. An insulating sleeve is placed around the crimp connector to complete the repair. The copper wire pigtail is then connected to the switch, receptacle, or other termination device. An example of a repaired receptacle outlet is also illustrated below.

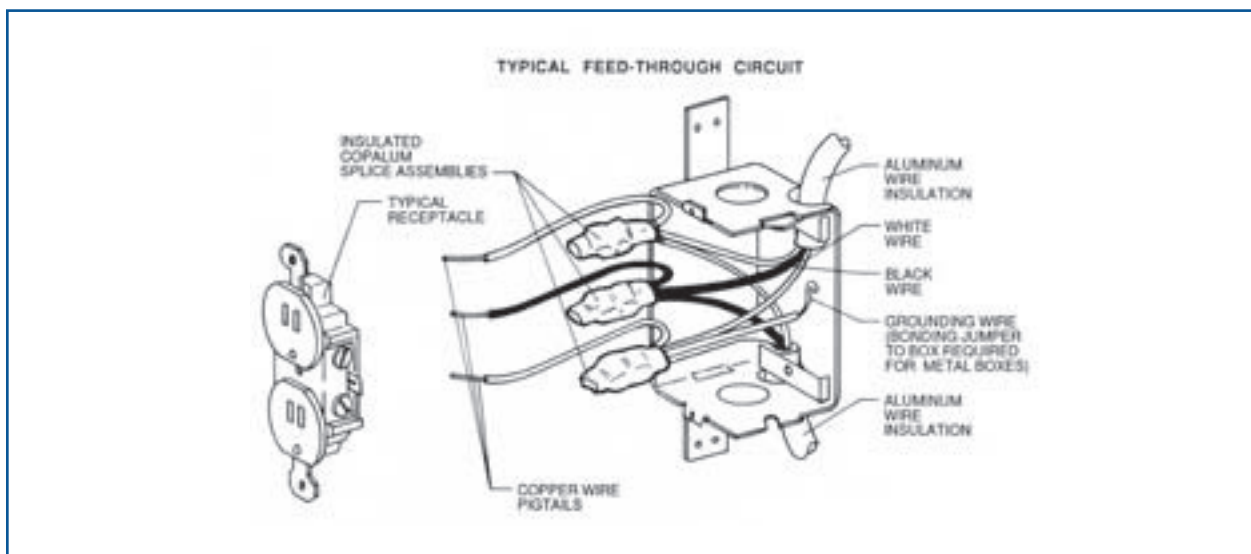
Recommended COPALUM Connector Repair

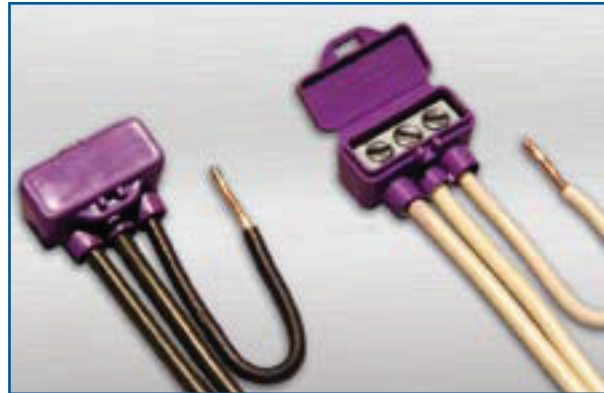
CPSC staff recognizes that copper replacement may be cost prohibitive and that the COPALUM repair may be unavailable in a locality. Based upon an evaluation that was, in part, CPSC supported,⁵ consumers are advised that, if the COPALUM repair is not available, the AlumiConn connector may be considered the next best alternative for a permanent repair. This repair method involves pigtailing using a setscrew type connector instead of the COPALUM crimp connector in the repaired connections. The AlumiConn connector has performed well in initial tests, but is too new to have developed a significant long-term safe performance history as the COPALUM repair. The repair should be conducted by a qualified electrician because careful, professional workmanship and thoroughness are required to make the AlumiConn connector repair safe and permanent.

The AlumiConn Connector

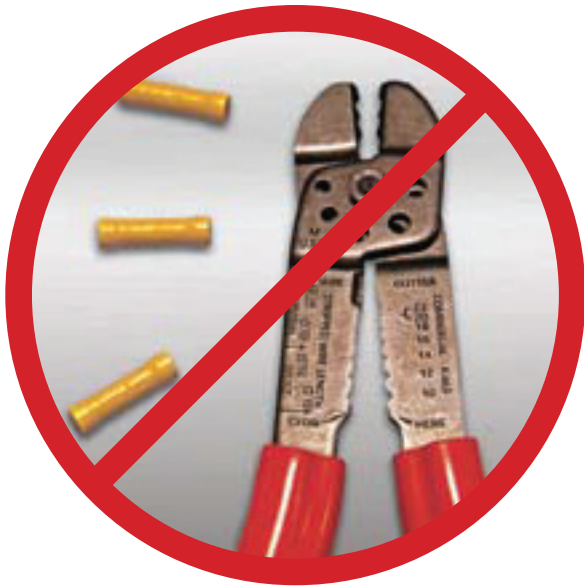
There are many other brands and types of crimp connectors – including those intended to be installed with a pliers-type of handtool – which are readily available to consumers at common retailers.

No other crimp connectors have been evaluated for connecting copper and aluminum conductors. CPSC staff strongly recommends against their use as a repair method.

Do Not Use Common Hand-Crimped Connectors with Aluminum Wire

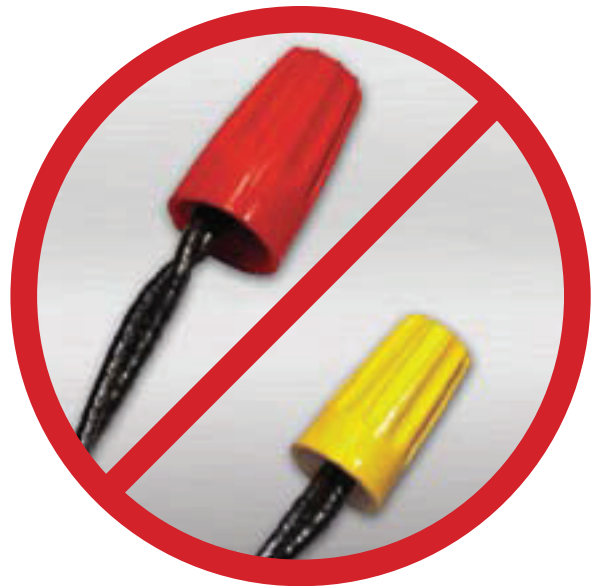
The first temporary repair involves pigtail with a twist-on connector. The effectiveness of “pigtail” using twist-on connectors has been evaluated by CPSC staff. In CPSC-sponsored laboratory testing and life tests, substantial numbers of these connectors overheated severely.

of twist-on connectors with aluminum wire. It is possible that some pigtail “repairs” made with twist-on connectors may be prone to even more failures than the original aluminum wire connectors. Accordingly, CPSC staff believes that this method of repair does not solve the problem of overheating present in aluminum-wired branch circuits.

“Pigtail” with Twist-on Connectors Is Not a Recommended Repair
